Manhole Inspection Summary

Manhole # S23UU1004MH

Insp Date: **11/30/06 8:06 AM**

Location Address: **5 SUNNY RD**

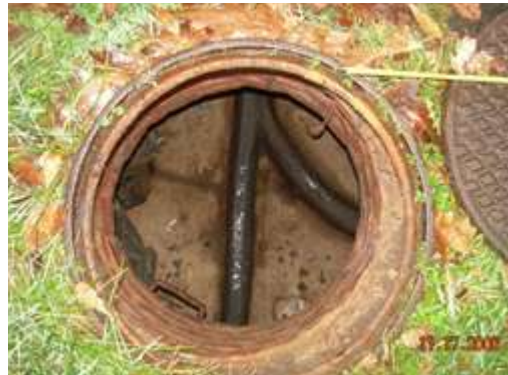
Top View

Offset: **3** (in.)

☐ Parged ☒ **Debris** (not Condition related)

Count: **2** Missing: **1** ☒ **Corroded**

Frame offset. Corroded and missing steps. Bench debris.

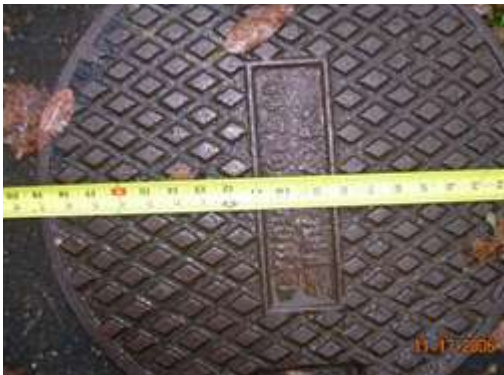
18 inch cover

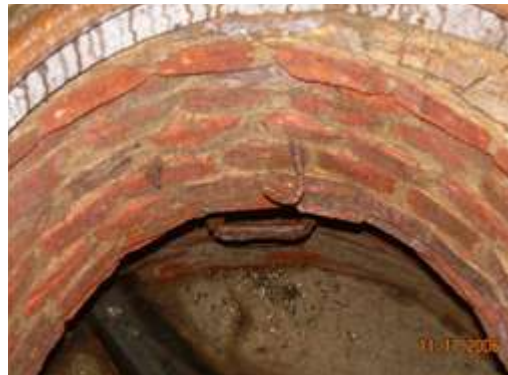
Defect

Condition: ☐ Sound ☒ **Cracked** ☐ Root Intrusion ☐ Loose Brick ☒ **Deteriorated**

Infiltration: ☐ None ☒ **Joint** ☒ **Cracks** ☐ Mortar ☐ Roots ☐ Wall

Adjustment deterioration, cracks, and infiltration. Barrel infiltration.

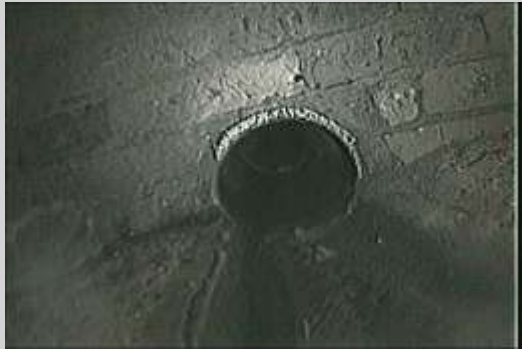
6 in. Circular Gravity Sewer Pipe Out @ 12 O'Clock

Pipe Material: **Clay** ☐ Pipe Lined

Invert Depth: **6.41** (ft.) Flow Characteristics: **Slow**

Infiltration: **None** Pipe Seal Cond: **Unknown**

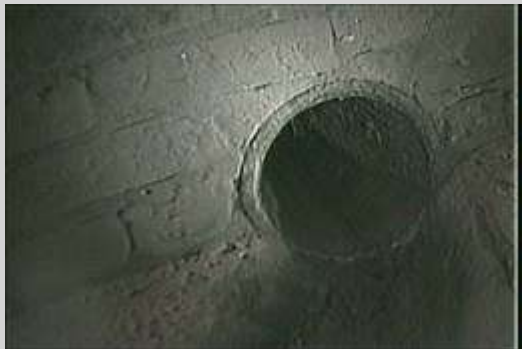
6 in. Circular Gravity Sewer Pipe In @ 3 O'Clock

Pipe Material: **Clay** ☐ Pipe Lined

Invert Depth: **6.13** (ft.) Flow Characteristics: **Slow**

Infiltration: **None** Pipe Seal Cond: **Sound**

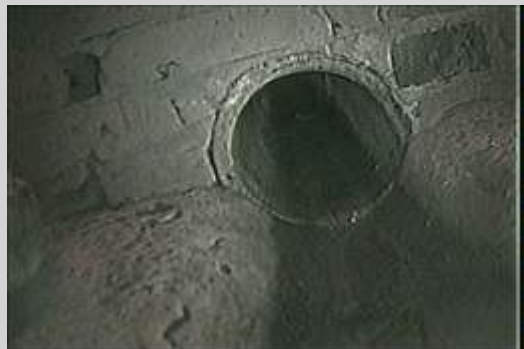
Pipe In @ 6 O'Clock

Pipe Material: **Clay**

Invert Depth: **6.26** (ft.) Flow Characteristics: **Slow**

Infiltration: **Evidence**

Pipe Seal Cond: **Unknown**
